Rock slope stability studies in Siskiyou National Forest

Greg Visconty
Portland State University

AN ABSTRACT OF THE THESIS OF Greg Visconty for the Master of Science in Geology presented May 20, 1988.

Title: Rock Slope Stability Studies in Siskiyou National Forest.

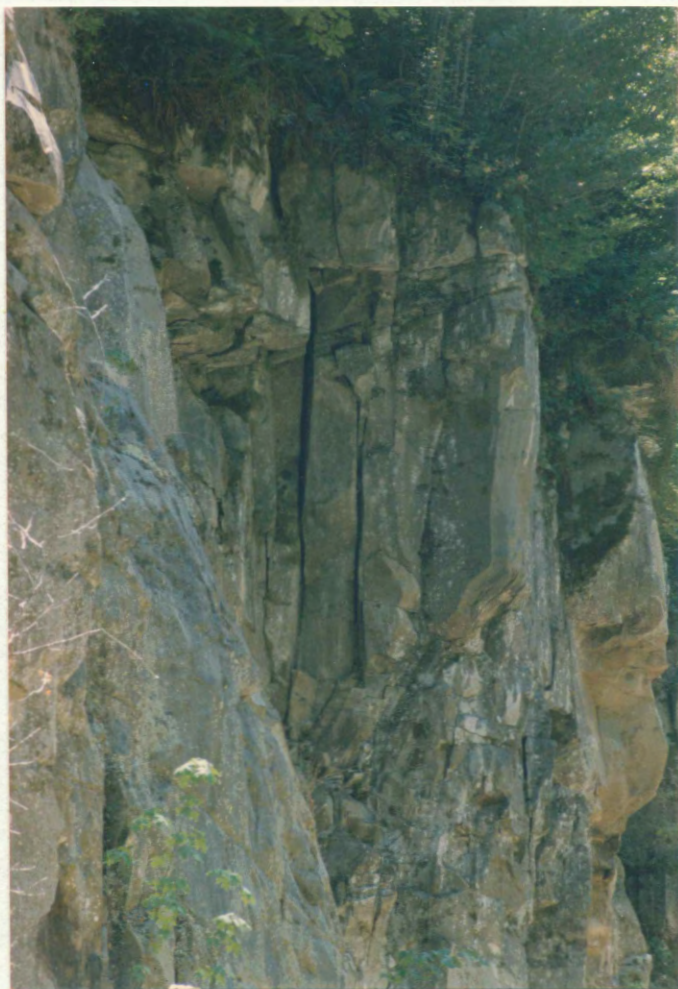
Figure 30. Powers 4 topplers.

Powers 4 contains joint controlled columns 25 meters tall at the southern end of this section, shown in Figure 30. They rest on the very soft load cast bedding described earlier, shown in Figure 31. As can be seen, these columns

have already moved, as evidenced by openings of approximately 10 centimeters at the top of the exposed joints. Should these columns fail, they would span highway 33, causing considerable damage.

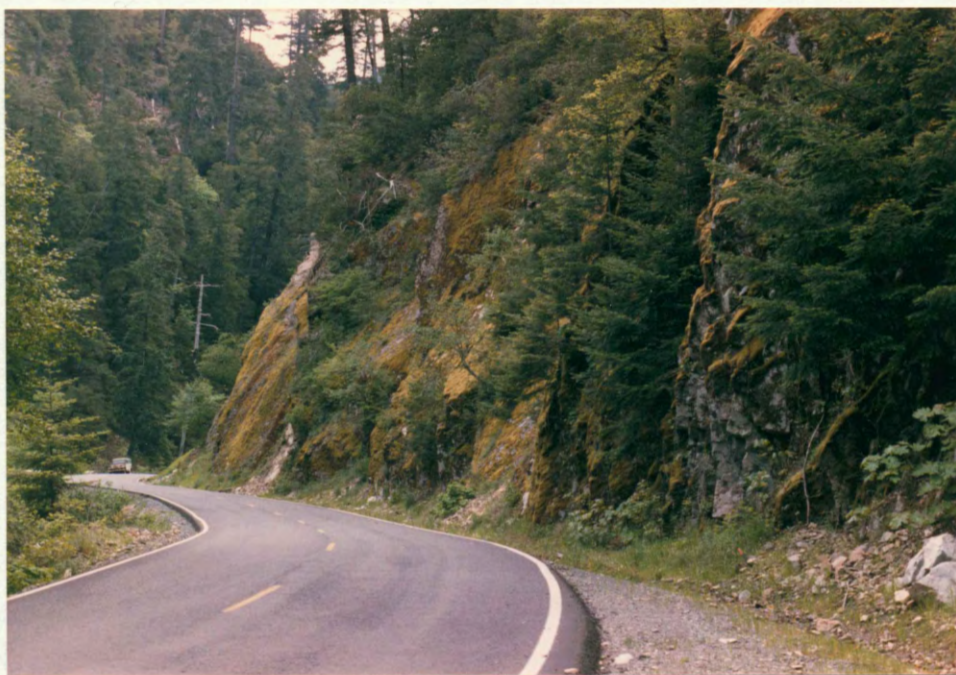
Figure 33. Elk River road cut.

and with heights of 27 meters above the road. Above the cliff top, the natural slope dip is approximately 50 degrees to heights of 500 meters above the road. Whether the form of the slope is by construction or natural failings is uncertain, as there are no maintenance records. According to the local log truck drivers who use this road often, the site is in constant need of cleanup of debris on the road.

Initial inspection of this site revealed several large blocks, 10 meters across, resting on inclined fault planes, and an area of falling debris containing boulders up to two meters in diameter. At no place is there a catch trench to collect the blocks as they fall, and they can roll onto and

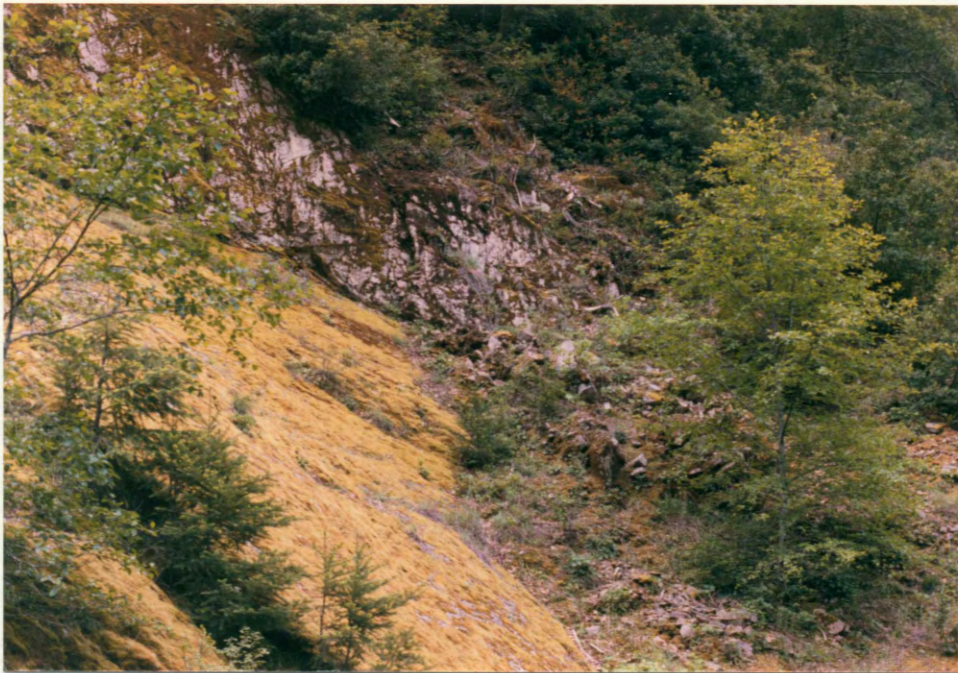
Figure 36. Potential wedge failure at Elk 2.

angle of friction is estimated at 22 degrees according to ϕ ranges for this type of discontinuity, as listed in Hoek and Bray (1981). A major joint system exposed in this outcrop acts as a tension release plane behind the wedge, oriented at due north, dipping 67 degrees west. With maximum water conditions, water pressures on each plane could reach 29.3 kPa, causing a loss of contact on the fault plane due to

buoyancy, and the water force acting on the tension crack could exceed 3978 kN. Under these conditions, the Factor of Safety is .78, and a minimum cohesive value of 70 kPa would be required to maintain stability. The wedges that existed on this fault below this point, have been removed, though

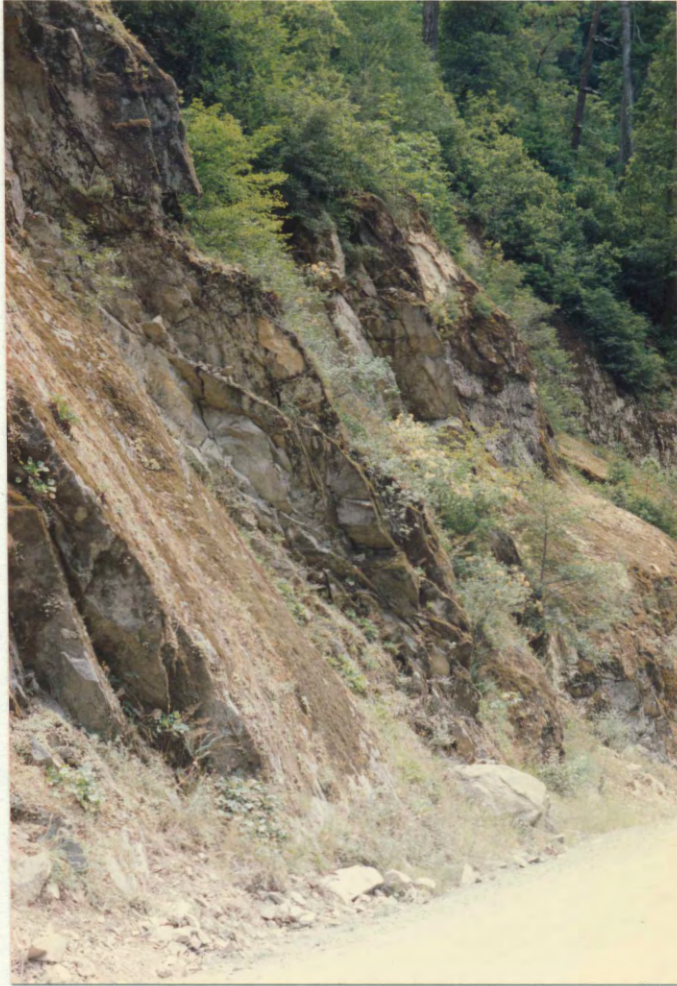
Figure 38. Second fault perched slab of Elk 3.

failures. The second fault of this outcrop, shown on the left in Figure 38, is located at the northern end of this section. Its strike is 35 degrees from that of the slope face, but there is apparently no release plane. The result of this orientation produces small blocks as seen throughout this outcrop.

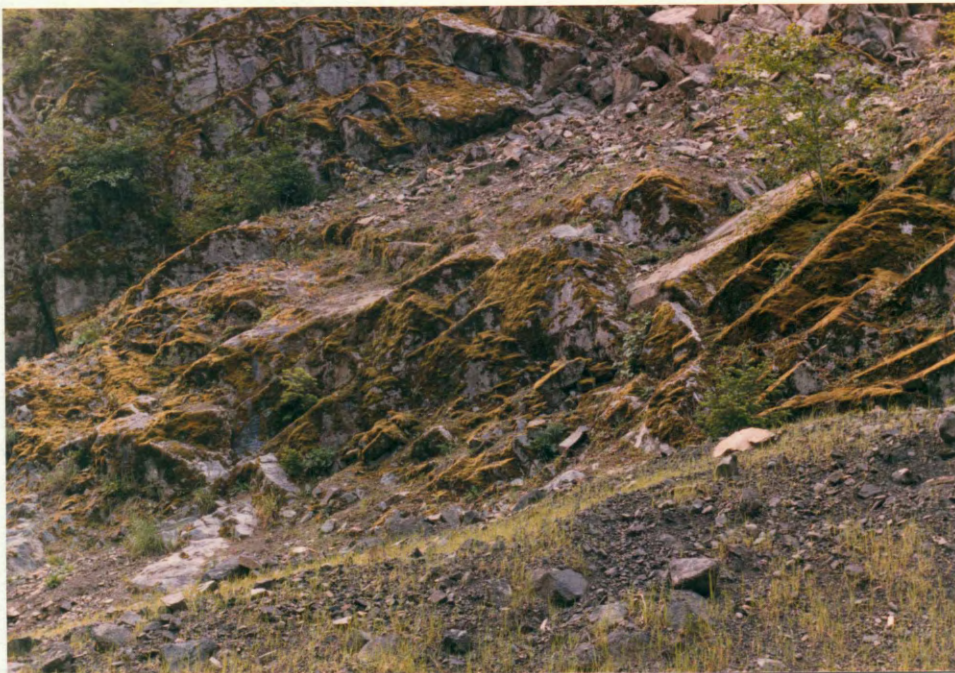
Figure 39. Potential plane failure at Elk 6.

Elk 6 contains one plane at 21.9 meters, oriented at 74 degrees, dipping 40 degrees northwest, which is within 14 degrees of the slope. It can be seen just to the right of center in Figure 39. When saturated, the Factor of Safety drops from 1.07 to $-.17$, and its cohesive value is 41 kPa.

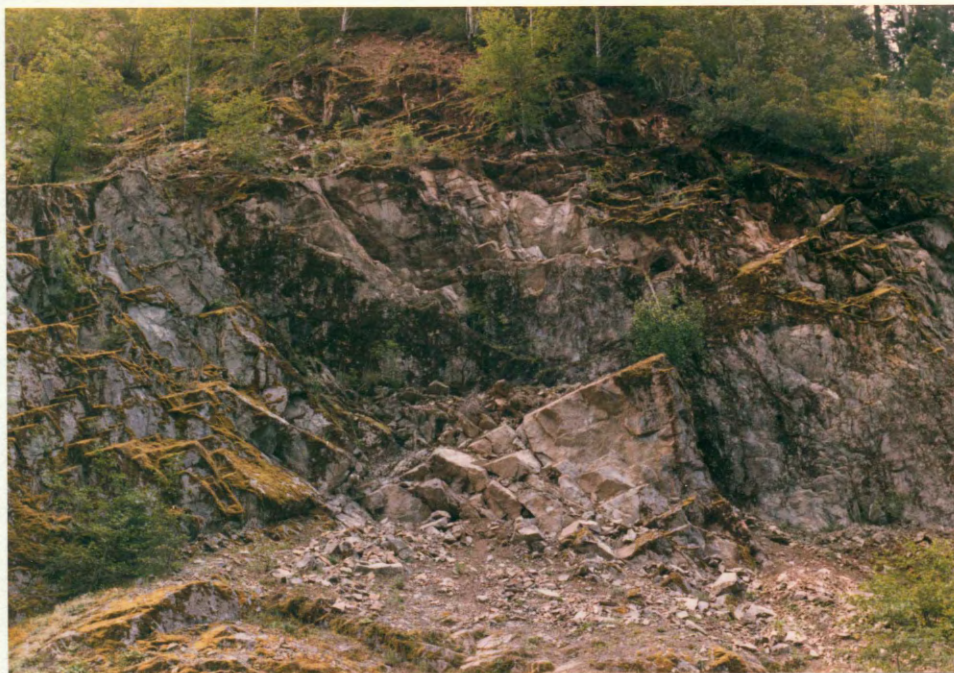
Figure 40. Major wedge at Elk 6.

This segment also contains a very prominent wedge, shown in Figure 40, below. From initial inspections this wedge is failing, but apparently by small blocks, and not as one large wedge. It has a release tension crack exposed in the upper center of Figure 40. On the stereonet, the intersection plunges at only 10 degrees, indicating a very stable condition. With maximum water conditions, each plane could reach a pressure of 70 kPa, and the tension crack downslope force could exceed 16,000 kN, resulting in loss of contact on one of its planes. But due to its orientation, the Factor of Safety would drop from 2.63 when dry to .99

when wet, and only 35 kPa of cohesion would be necessary to maintain stability. It looks much worse than it is. There is only the hazard of small pieces of it working out and falling. Its present condition could be due to its use as a rip rap source, but there are no production records to substantiate this.

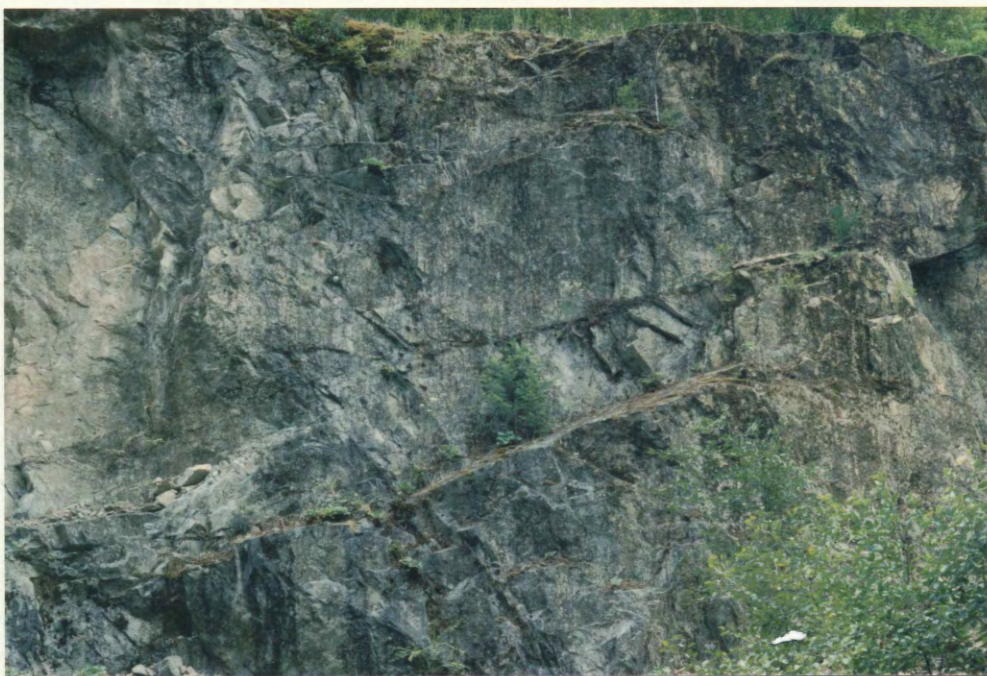
Figure 41. Trace of wedge at Elk 8.

this system are 56 kPa pressure on each plane, with 94,000 kN on the tension crack (due to its projected height). The Factor of Safety would decrease from 1.50 when dry to .82 when wet, and a cohesive value of only 20 kPa will maintain stability. The trace of this wedge is shown in Figure 41, with the daylighting intersection just to the left of center.

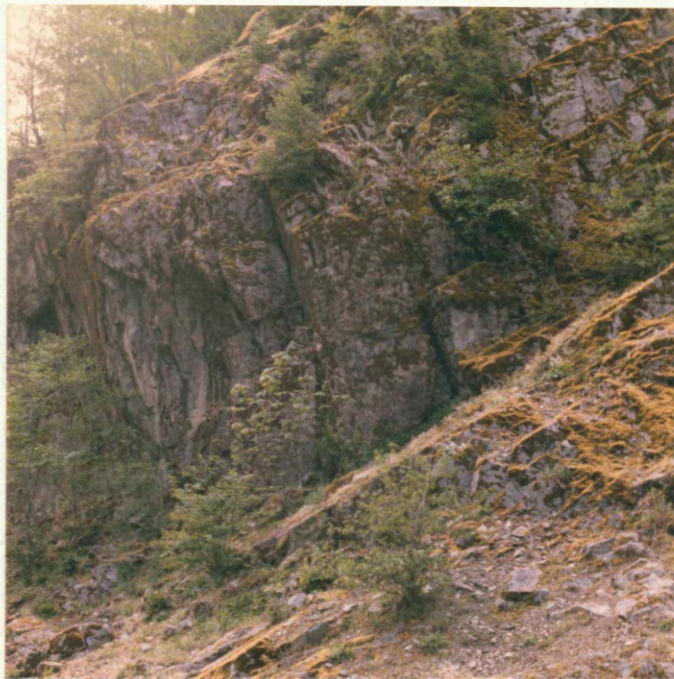
Figure 42. Topplers at Elk 8, looking north.

This section also contains some large blocks, up to four meters tall, which perch on one of the more prominent joints, shown in Figure 42. These present a hazard to the road because they lean out at this time, and as they move and topple off the edge, they will fall directly onto the

road.

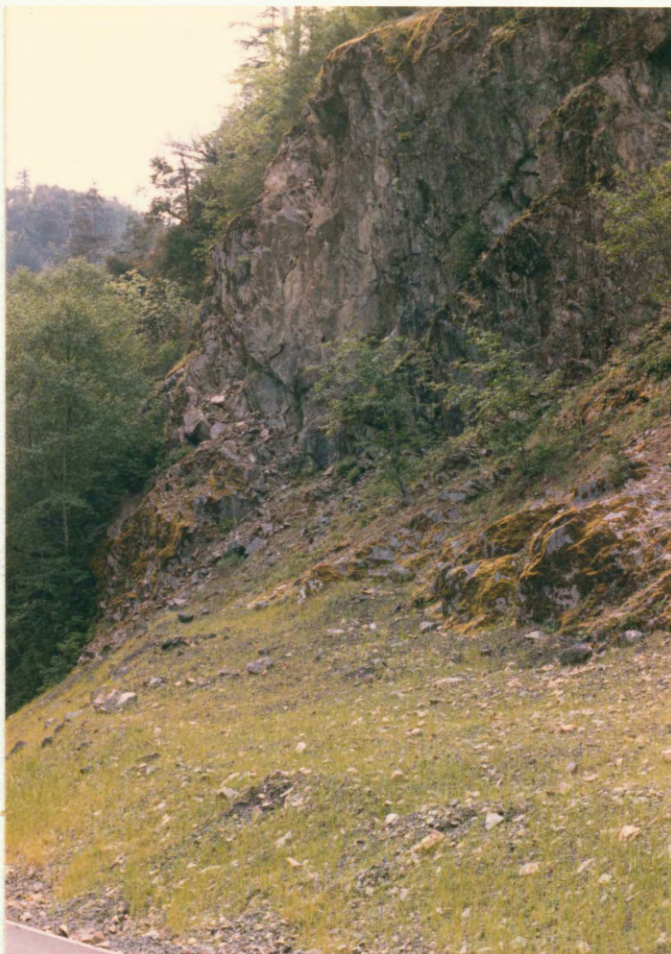
Figure 43. Elk 10, looking north.

The construction of Forest Service road 5325 did not allow for any catch trench between it and the outcrop. There does not appear to have been any room for a trench between the outcrop and Elk River. Most of the hazard will

be from small blocks working out of the slope, and falling or rolling to and across the road. The exceptions are the two loose slabs discussed in Elk 3. Due to the highly fractured nature of the slabs, bolting appears to be impractical, yet bringing the slabs down would cause extensive damage to the recently paved road. It may be possible to contain them with a bolt and net system.
